Safety Alert 013

Title: Potterton Powermax HE - Flue/Condensate Connector Erosion

Date issued: 15 November 2013

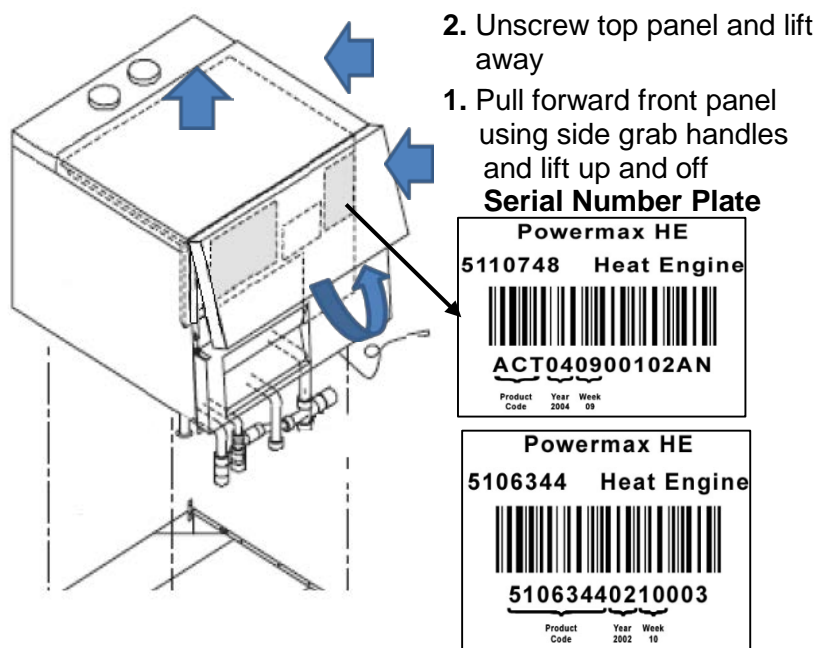
Figure 1. General Access

When attending a Powermax HE boiler first check to see if the serial number is in the identified range as listed in Table 1 (below). The serial number is on the data plate which is located as shown below (Fig 1) and contains two examples showing details of the year and week (YY WW) of production.

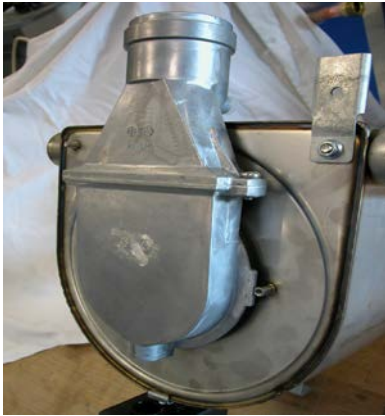
The problem identified centres around the aluminium material that was used to form the integral flue/condensate connector on the earlier production models. Through continuous field monitoring, it came to the attention of Baxi Heating Ltd., that this material is subject to erosion and the rate of erosion is dependant on usage patterns and local site installation conditions.

Figure 2
Aluminium flue/condensate connector attached to the rear of the heat exchanger (Photograph shows the view from the rear of the boiler)

Baxi Heating Ltd., **recommends** that all the aluminium components of this type are exchanged irrespective of their current condition.

Baxi Heating Ltd., requests that any Gas Safe registered engineer identifying an aluminium flue/condensate connector fitted on this range of boilers advises the customer to make arrangements for an engineer nominated by Baxi to supply and fit a replacement plastic flue/condensate connector free of charge*.

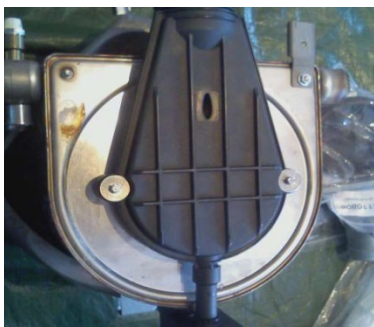
Figure 4
Black composite plastic flue/condensate connector attached to the rear of the heat exchanger (Photograph shows the view from the rear of the boiler)

- 3) If the component is the black composite plastic type **no further action** is required under this Safety Alert, **however** all appliance checks in accordance with GSIUR 26(9)⁽²⁾ must be completed and any subsequent actions applied as appropriate.

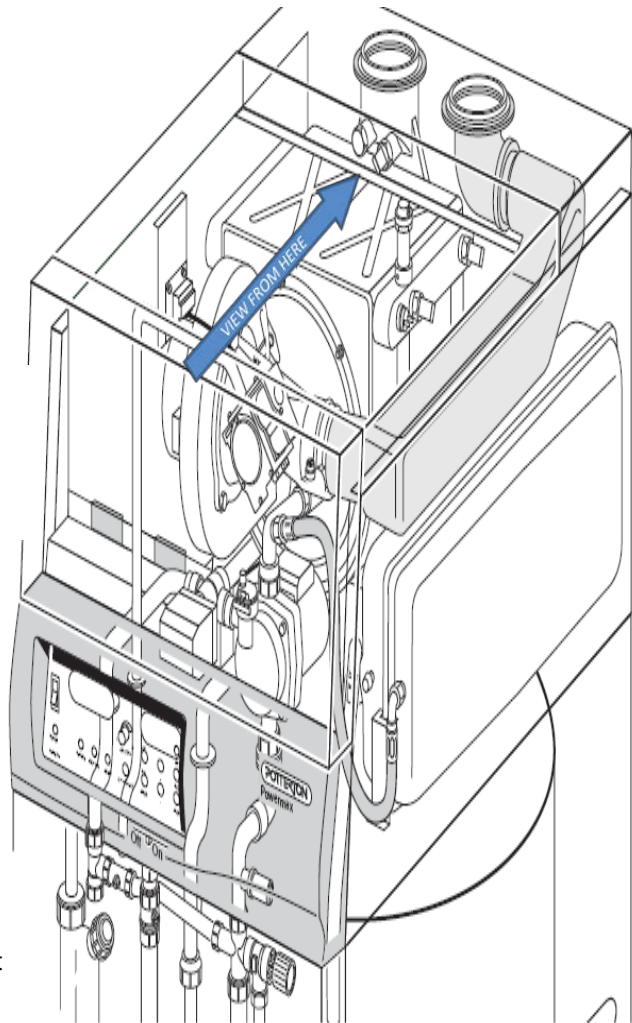
Figure 3
Location of condensate connector

- 1) The flue/condensate connector is located behind the heat engine at the rear of the appliance. Refer to Figure 1 for access.
- 2) The top of the flue/condensate connector can be viewed from the front of the boiler with the front and top panels removed as shown in Figures 2 & 3. If the boiler has already been fitted with a new flue gas/condensate connector this will be black composite plastic (Figure 4) rather than aluminium (Figure 2).
