Safety Alert 022

Title: Bosch/Neff gas hob product modification

Date issued: 22 February 2017

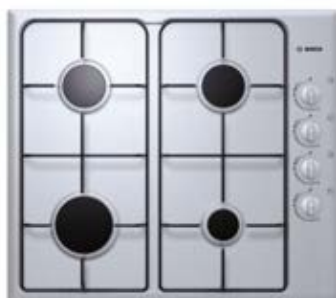
NGU4151DB - Bosch
FD 8901 - 9110

BSH is offering every owner of an affected appliance a free replacement gas connector by an authorized service engineer at the owner's home.

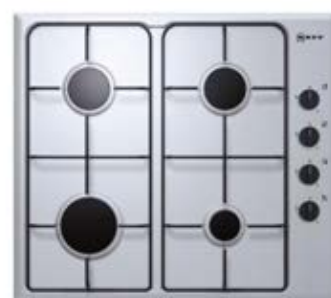
T20S31N0 - Neff
FD 8901 - 9110

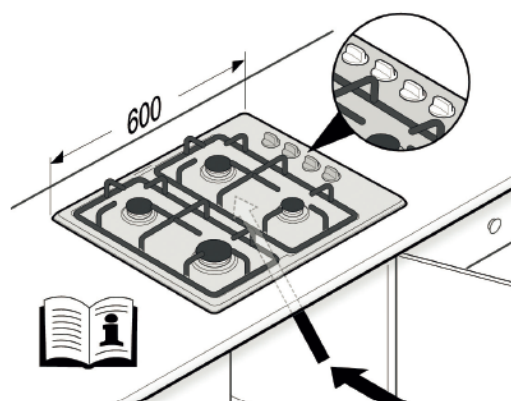
Note down the model number (E-Nr) and batch number (FD) on the rating plate on your appliance or original user manual.

Check underneath of appliance or original user manual.
